Town of Nanton

2025 Road Assessment

CIMA+ file number: Z0027712
September 2025

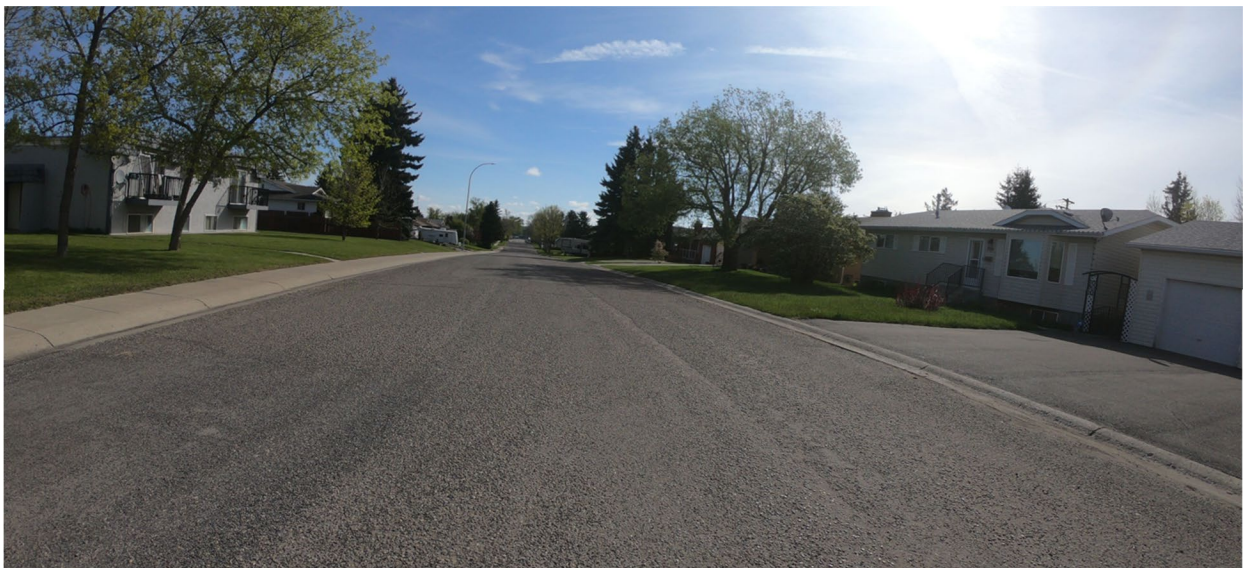
- 18th Street (26th Avenue to 23rd Avenue) – Moderate longitudinal and transverse cracking throughout, with minor alligator cracking in areas. Sever age hardening and surface raveling in areas. Milling and Paving is recommended.

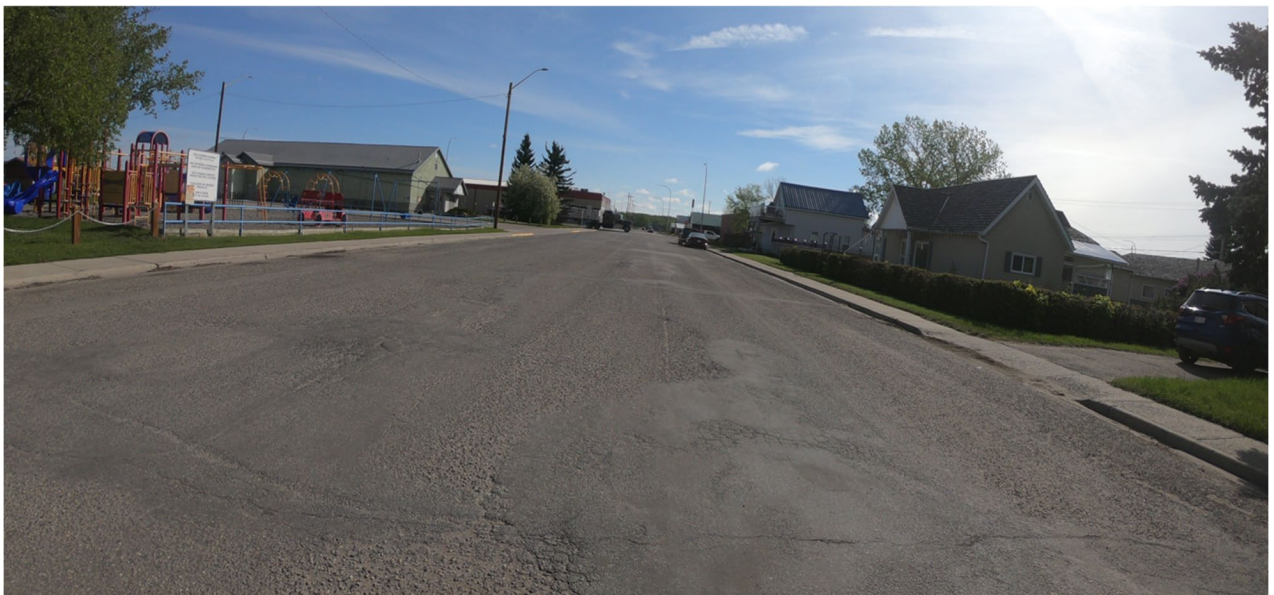
1.2.3 R3 – 18th Street (22nd Avenue to Highway 2 – Southbound Lane)

- 2600 m² of full width and depth road replacement.

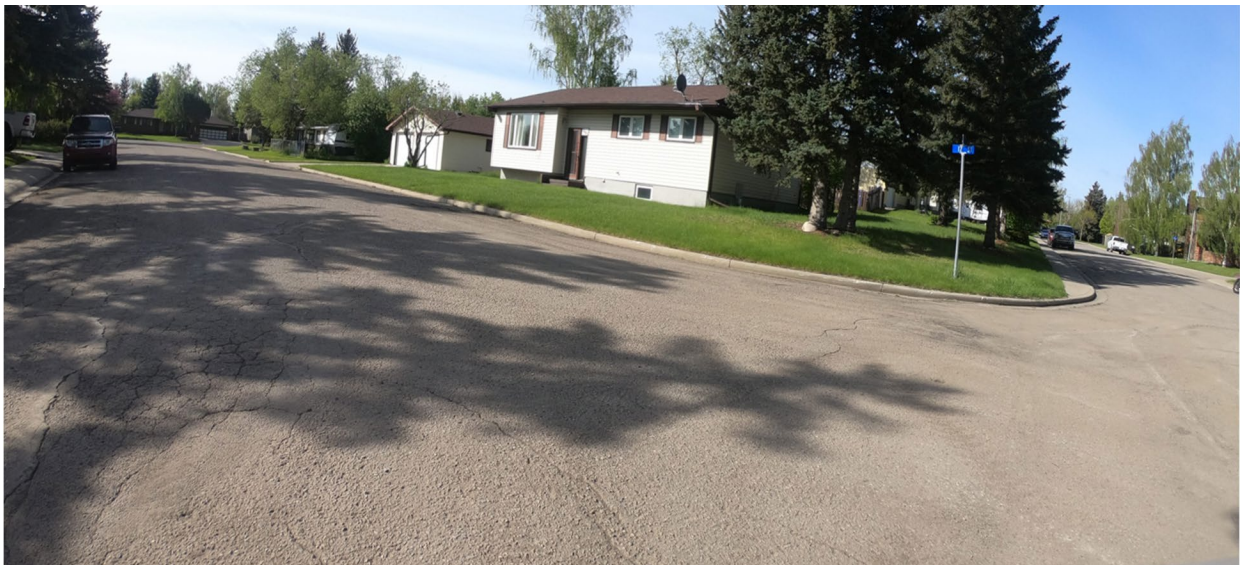
1.3.1 R4 – 17th Street (16th Avenue to 23rd Avenue)

- 17th Street (16th Avenue to 23rd Avenue) – Moderate longitudinal and transverse cracking throughout, with moderate alligator cracking near the intersection of 16th Street. Moderate age hardening and surface raveling in areas. Structural failure near the intersection of 16th Street is likely, and replacement of full road structure is recommended for this area. Milling and paving is recommended for the remaining road section.

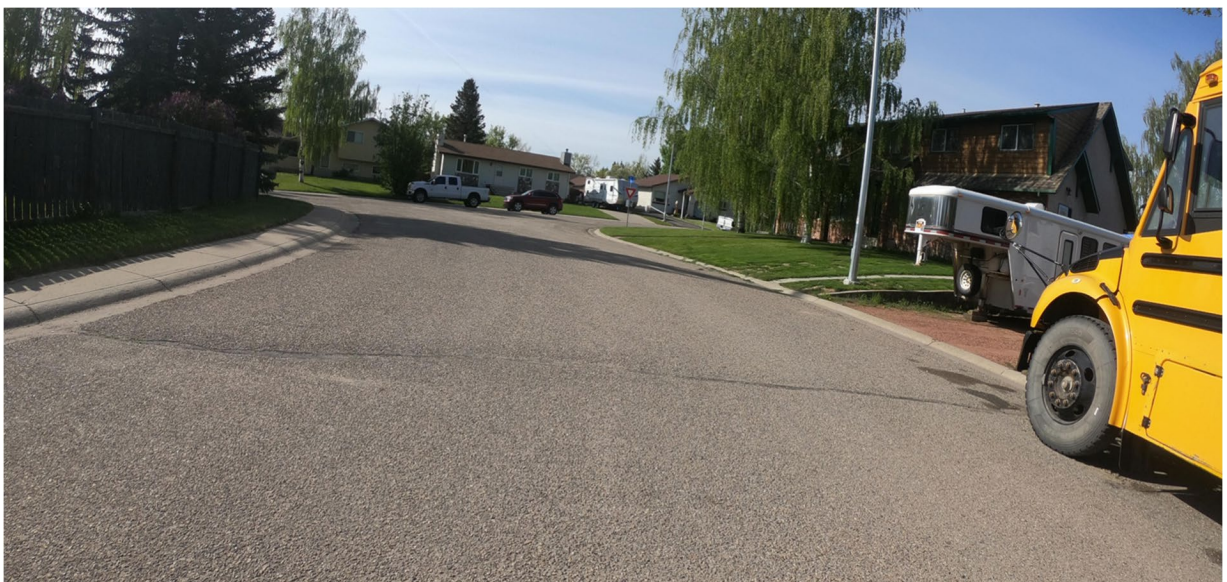
1.4.1 R5 – 15th Street (22nd Avenue to 16th Street)

- 15th Street (22nd Avenue to 16th Street) – Minor longitudinal and transverse cracking throughout. Moderate age hardening and surface raveling in areas. Milling and Paving is recommended.

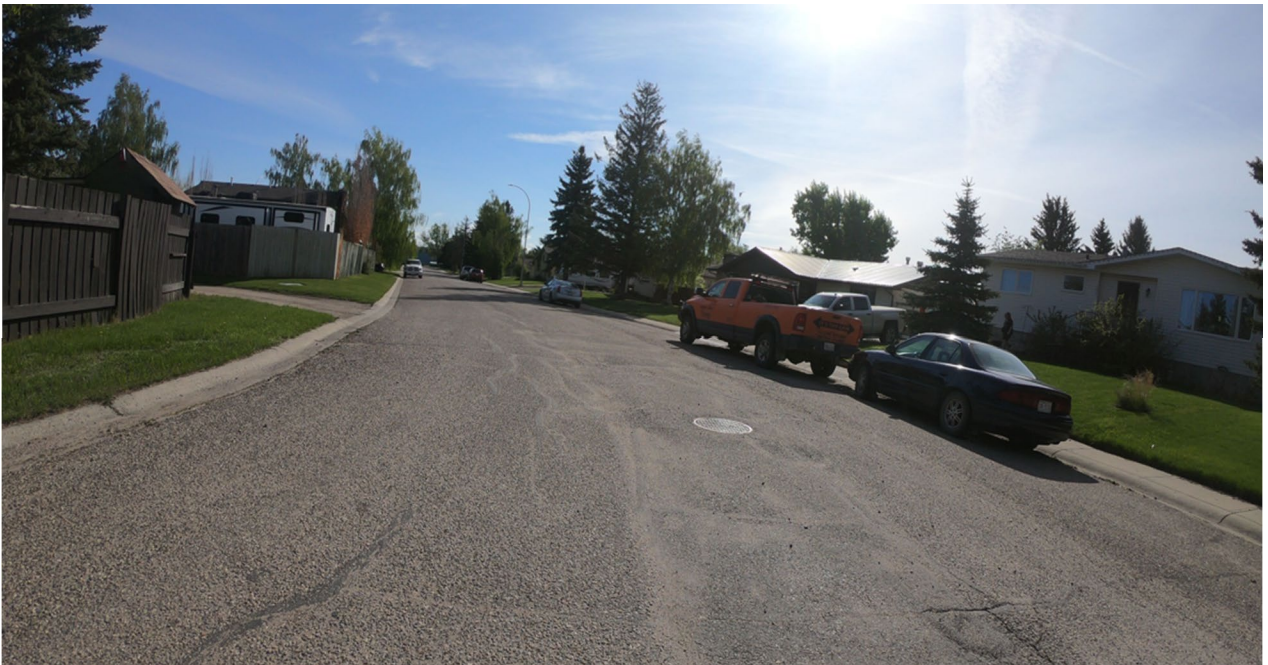
1.4.2 R6 – 16th Street (26th Avenue to 22nd Avenue)

- 16th Street (26th Avenue to 22nd Avenue) – Minor longitudinal and transverse cracking throughout. Moderate age hardening and surface raveling in areas. Milling and Paving is recommended.

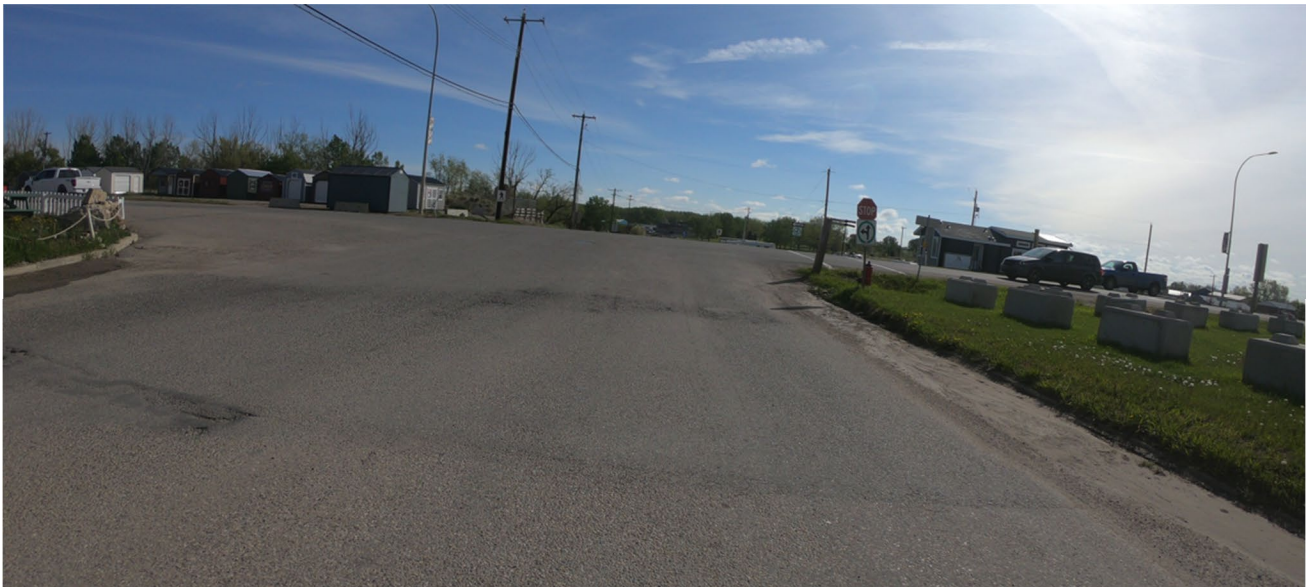
1.4.3 R7 – 18th Street (Highway 2 – Southbound Lane to Northbound Lane)

- 18th Street (Highway 2 -Southbound Lane to Northbound Lane) – Minor longitudinal and transverse cracking throughout, with moderate alligator cracking at the intersections of Highway 2 north and south bound lanes. Sever age hardening and surface raveling in areas. Milling and Paving is recommended.

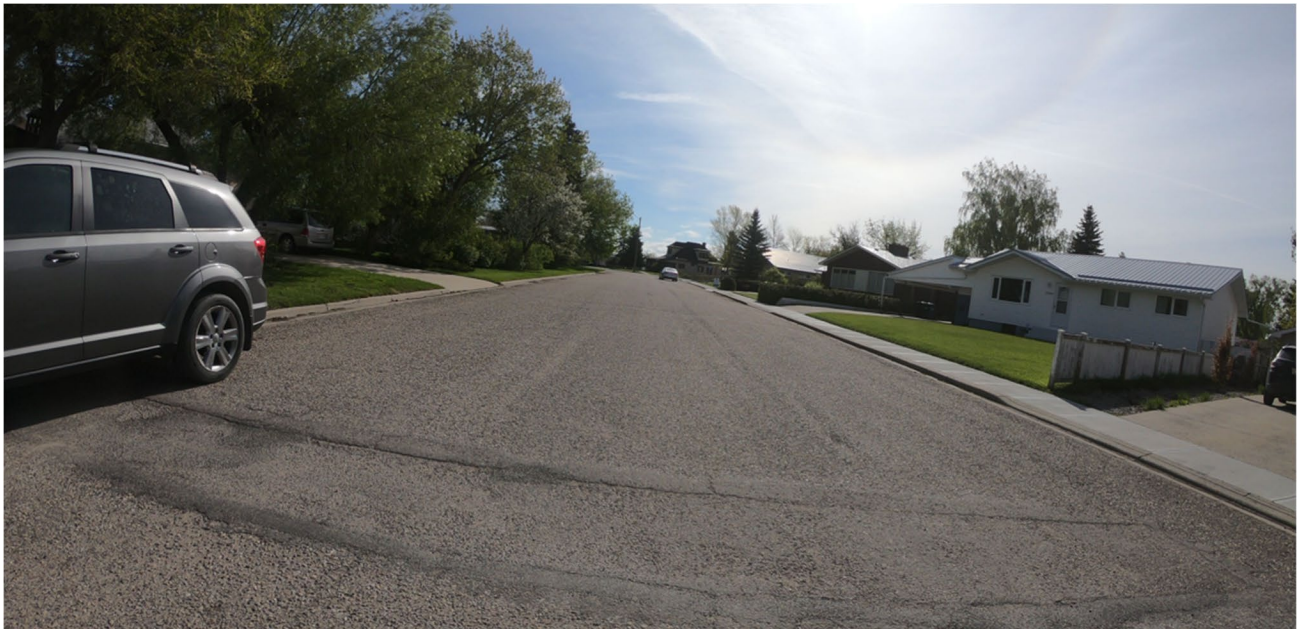
1.4.4 R8 – 19th Street (26th Avenue to 24th Avenue)

- 19th Street (26th Avenue to 24th Avenue) – Moderate longitudinal and transverse cracking throughout, with minor alligator cracking at the intersection of 26th Avenue. Sever age hardening and surface raveling in areas. Milling and Paving is recommended.

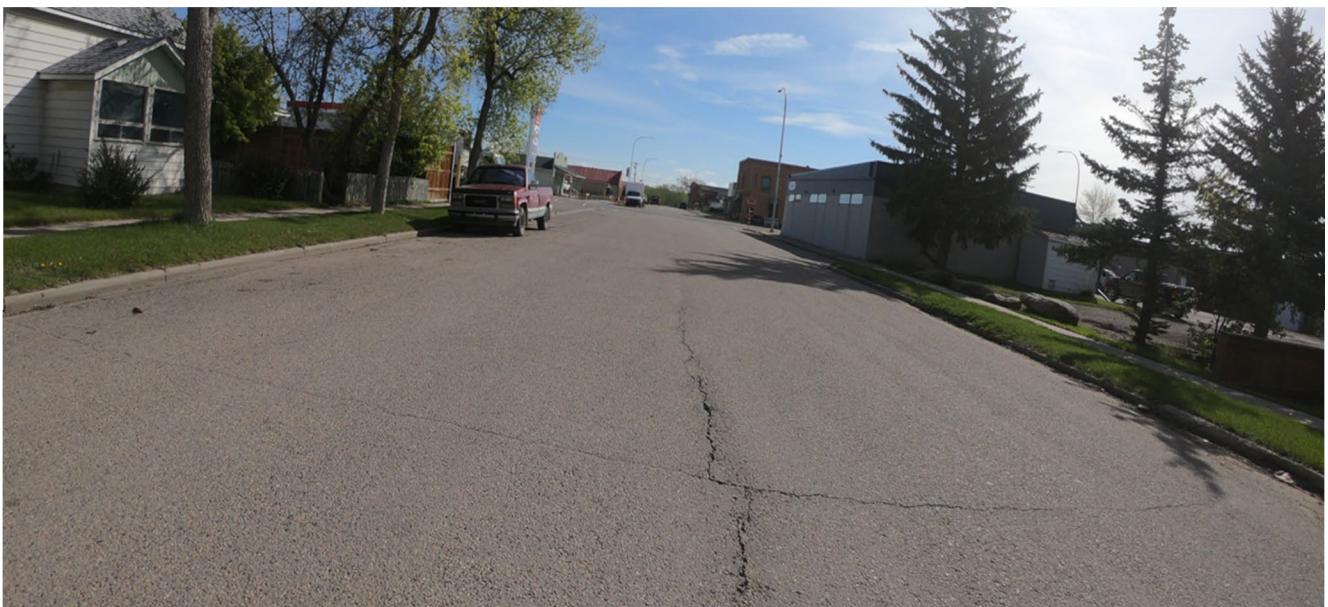
1.4.5 R9 – 19th Street (22nd Avenue to Highway 2 – Southbound Lane)

- 19th Street (22nd Avenue to Highway 2 -Southbound Lane) – Moderate longitudinal and transverse cracking throughout, with minor alligator cracking at the intersection of 21st Avenue. Moderate age hardening and surface raveling in areas. Milling and Paving is recommended.

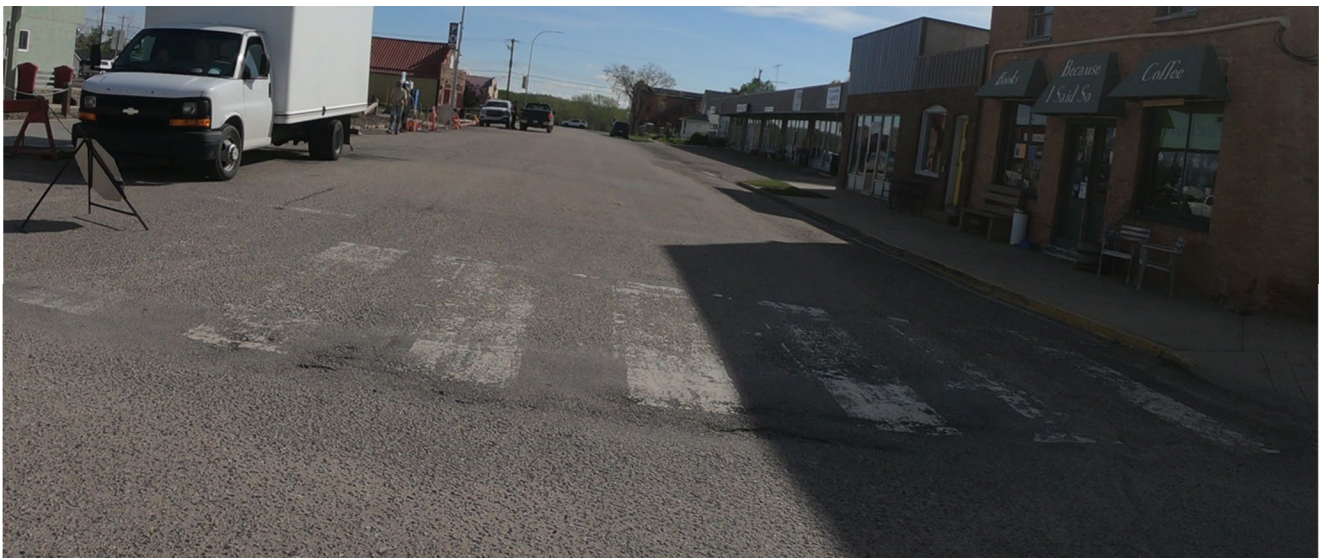
1.4.6 R10 – 20th Street (Highway 2 – Southbound Lane to Highway 2 – Northbound Lane)

- 20th Street (Highway 2 - Southbound Lane to Highway 2 – Northbound Lane) – Moderate longitudinal and transverse cracking throughout, with minor alligator cracking. Moderate age hardening and surface raveling in areas. Milling and Paving is recommended.

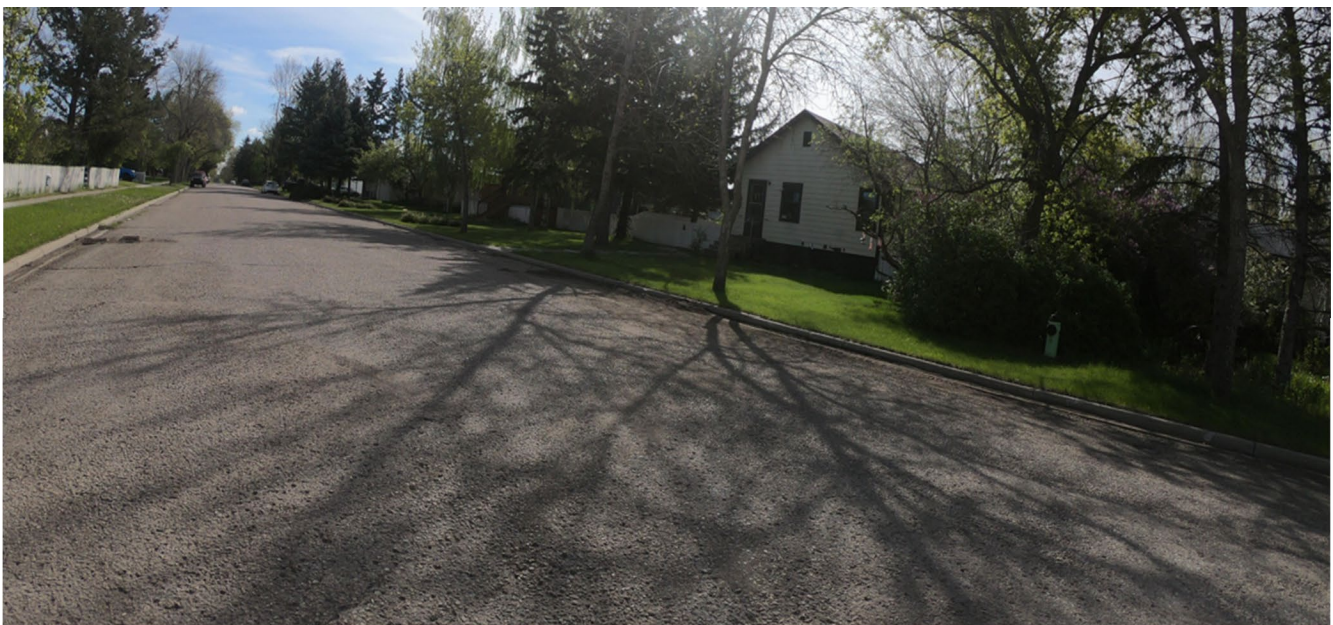
1.4.7 R11 – 21st Street (26th Avenue to 24th Avenue)

- 21st Street (26th Avenue to 24th Avenue) – Minor longitudinal and transverse cracking throughout, with minor alligator cracking at the intersection of 26th Avenue. Sever surface raveling in areas. Milling and Paving is recommended.

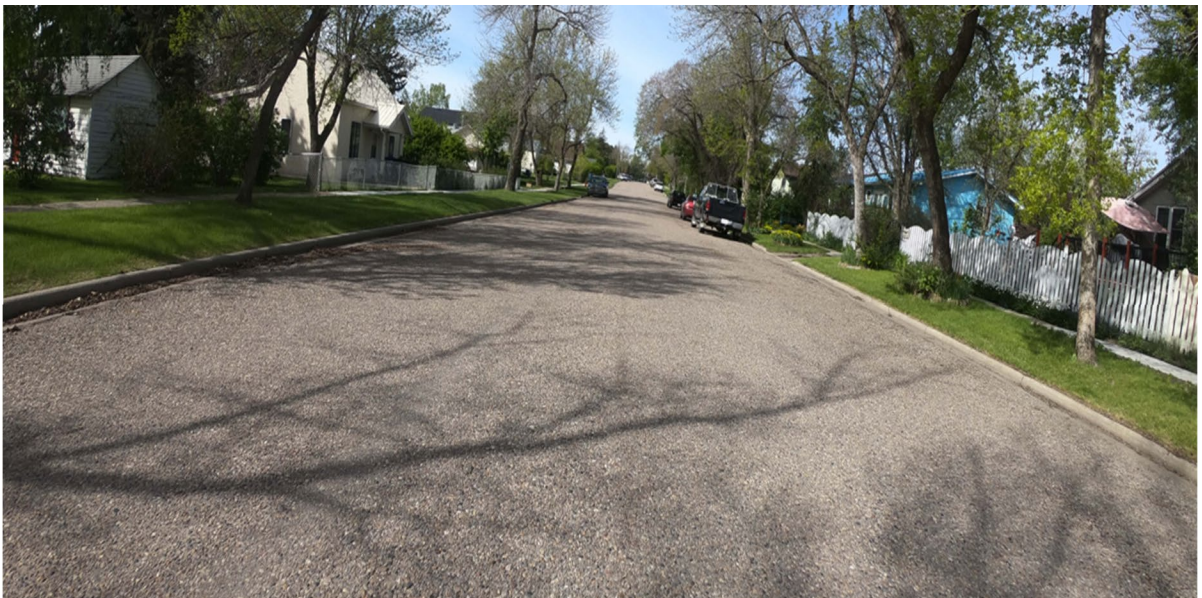
This section on 23rd Street is moderately deteriorated, with minor longitudinal and transverse cracking, moderate surface raveling.

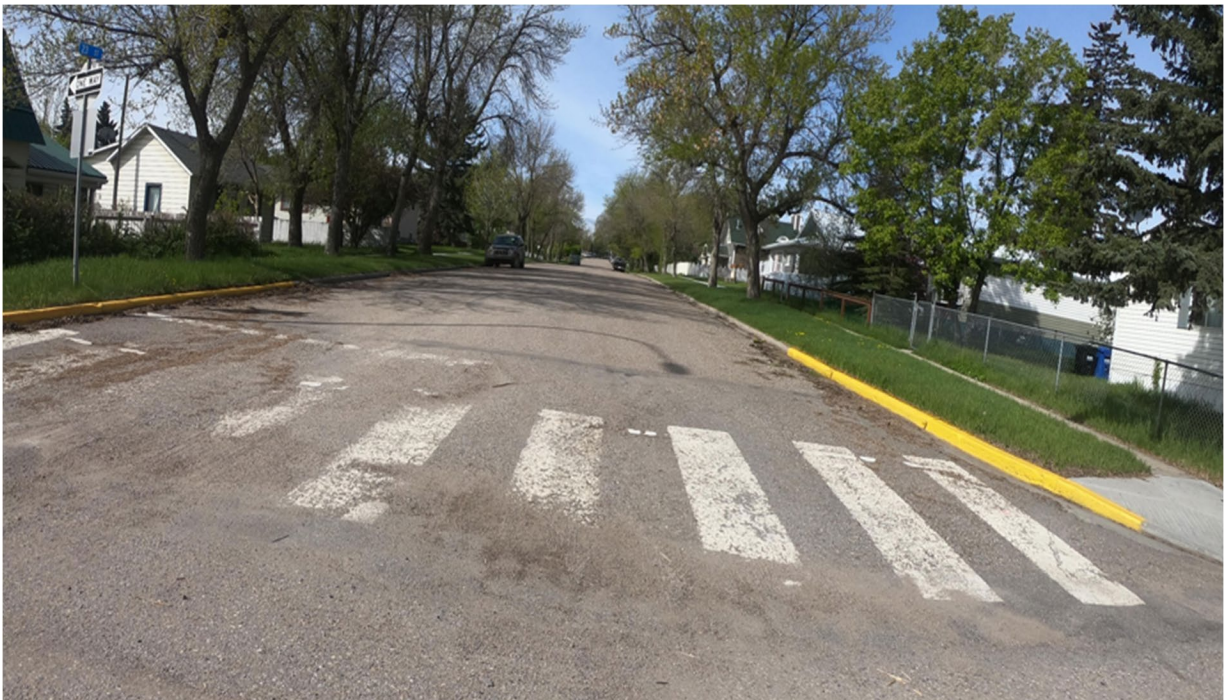
This section on 23rd Street is moderately deteriorated, with minor longitudinal and transverse cracking, moderate surface raveling.

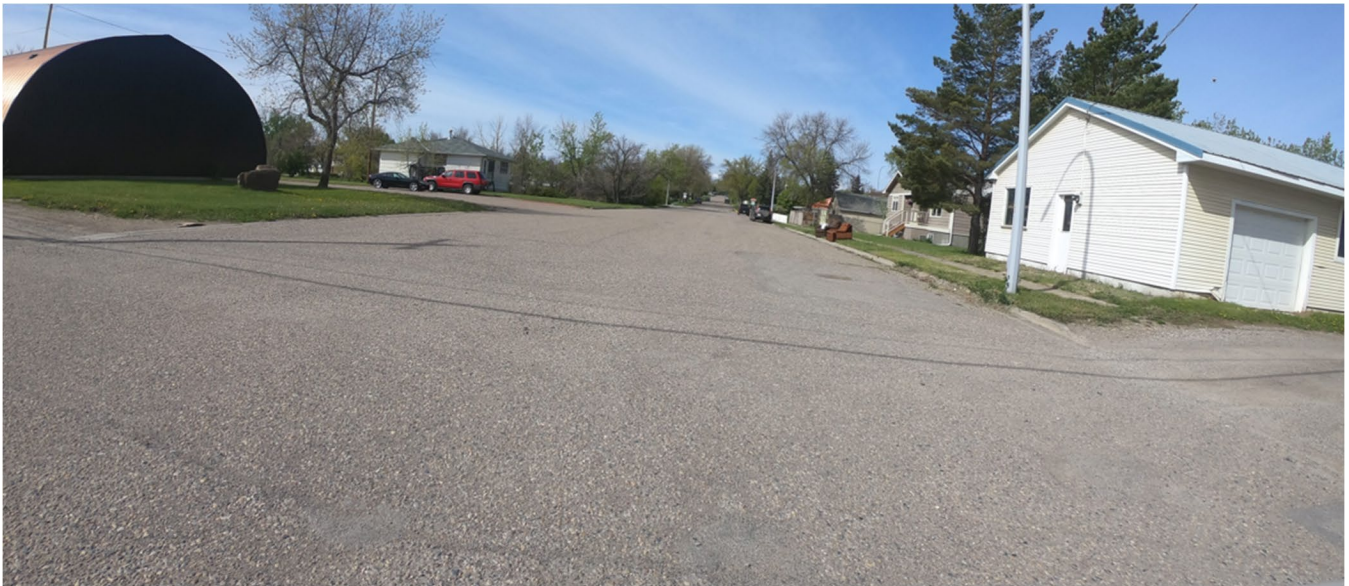
This section on 25th Street is moderately deteriorated, with minor longitudinal and transverse cracking, moderate age hardening and surface raveling.

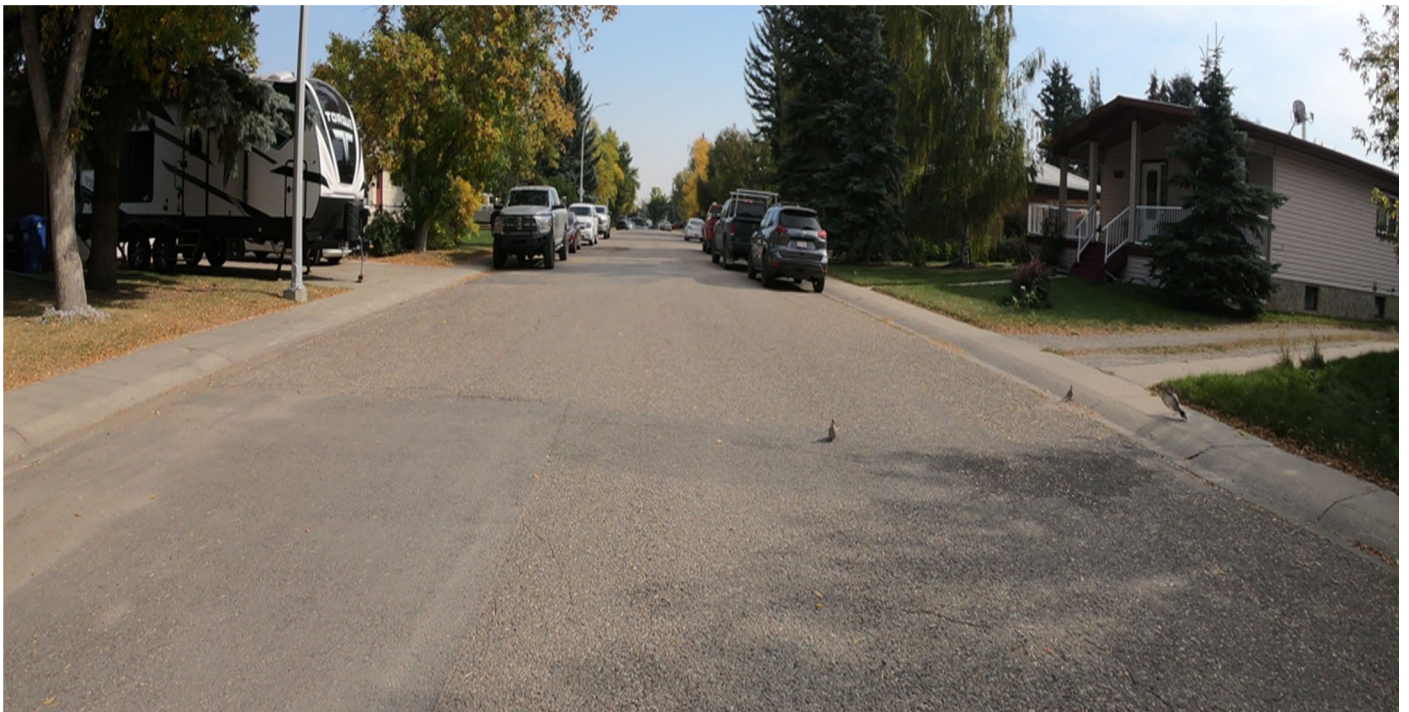
This section on 25th Street is moderately deteriorated, with minor longitudinal and transverse cracking, moderate surface raveling.

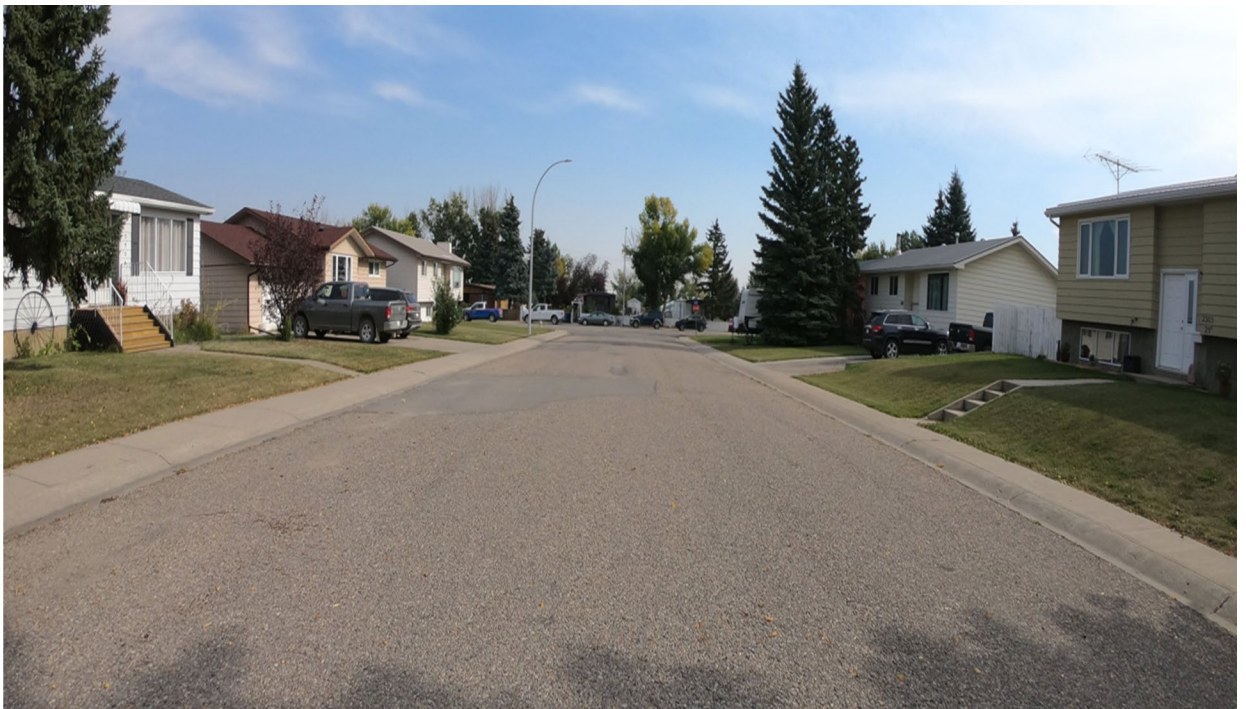
This section on 26th Street is moderately deteriorated, with minor longitudinal and transverse cracking, moderate surface raveling.

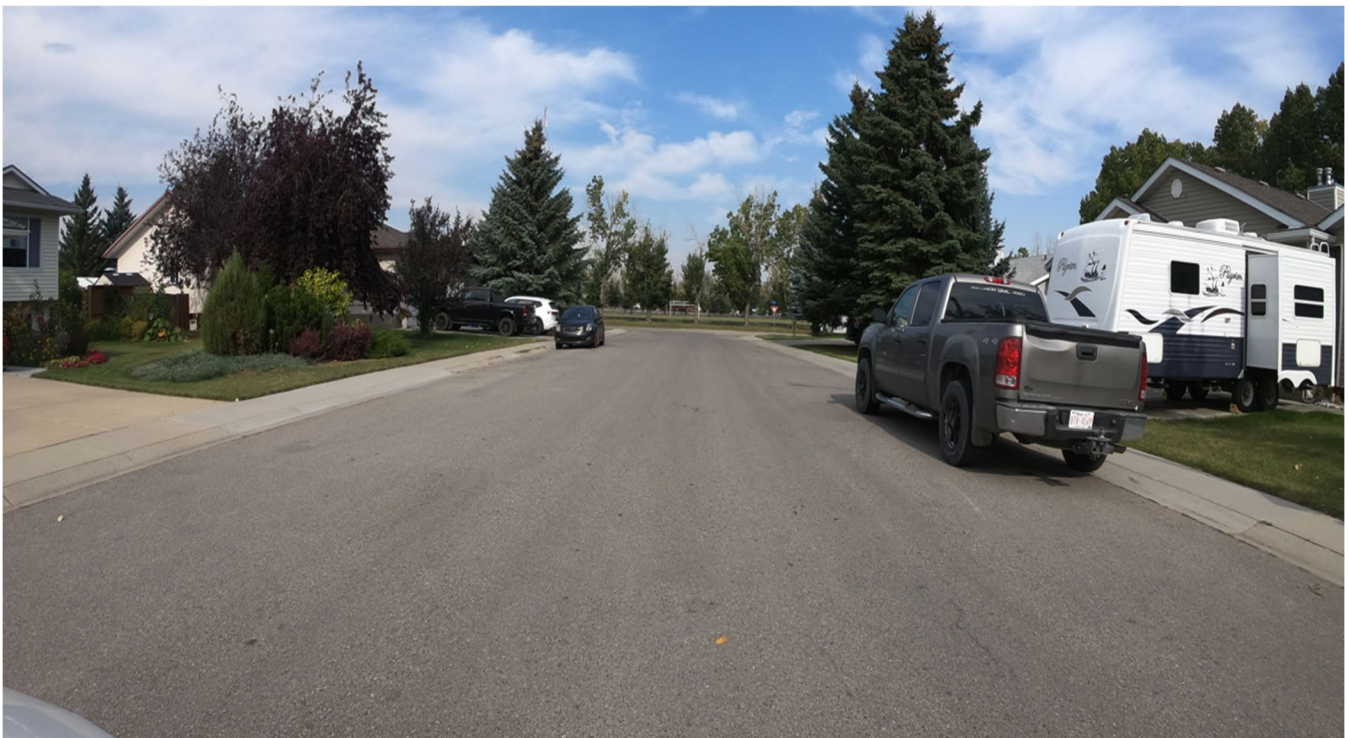
This section on 26th Street is moderately deteriorated, with minor longitudinal and transverse cracking, moderate surface raveling.

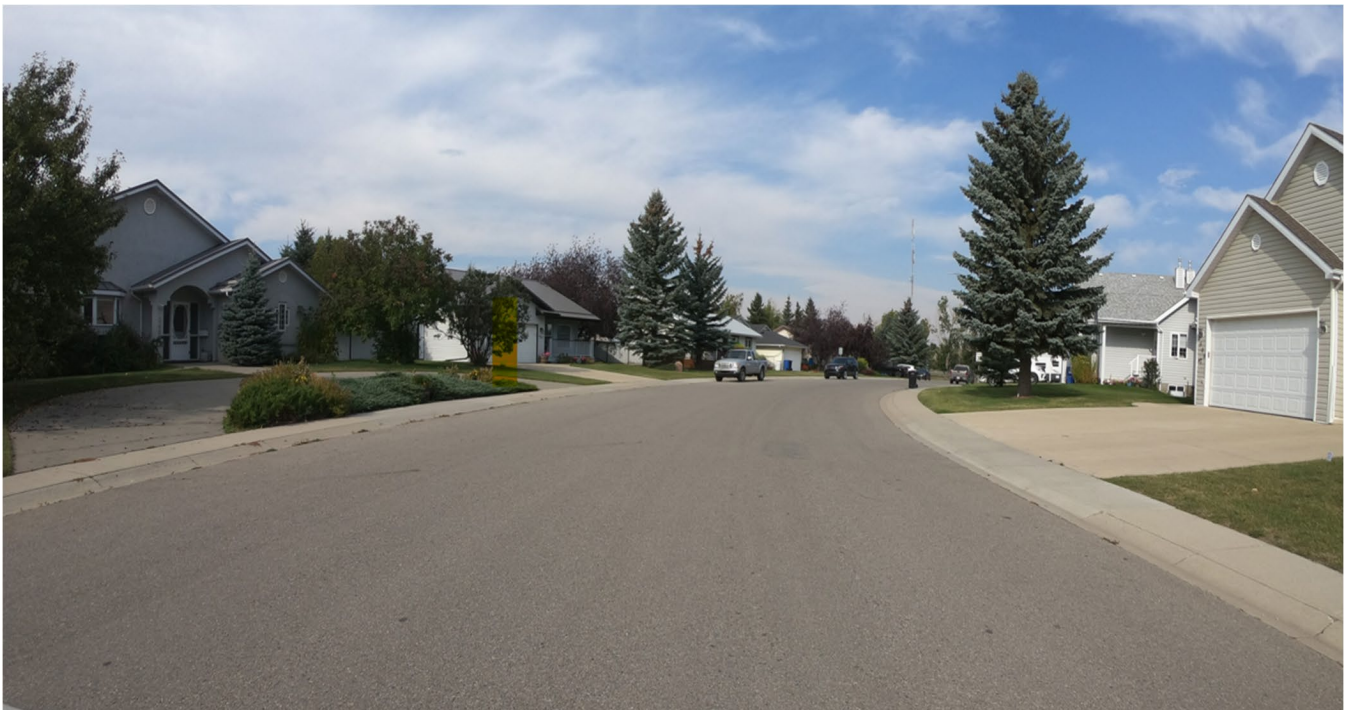
This section on 26th Street is moderately deteriorated, with minor longitudinal and transverse cracking, moderate surface raveling.

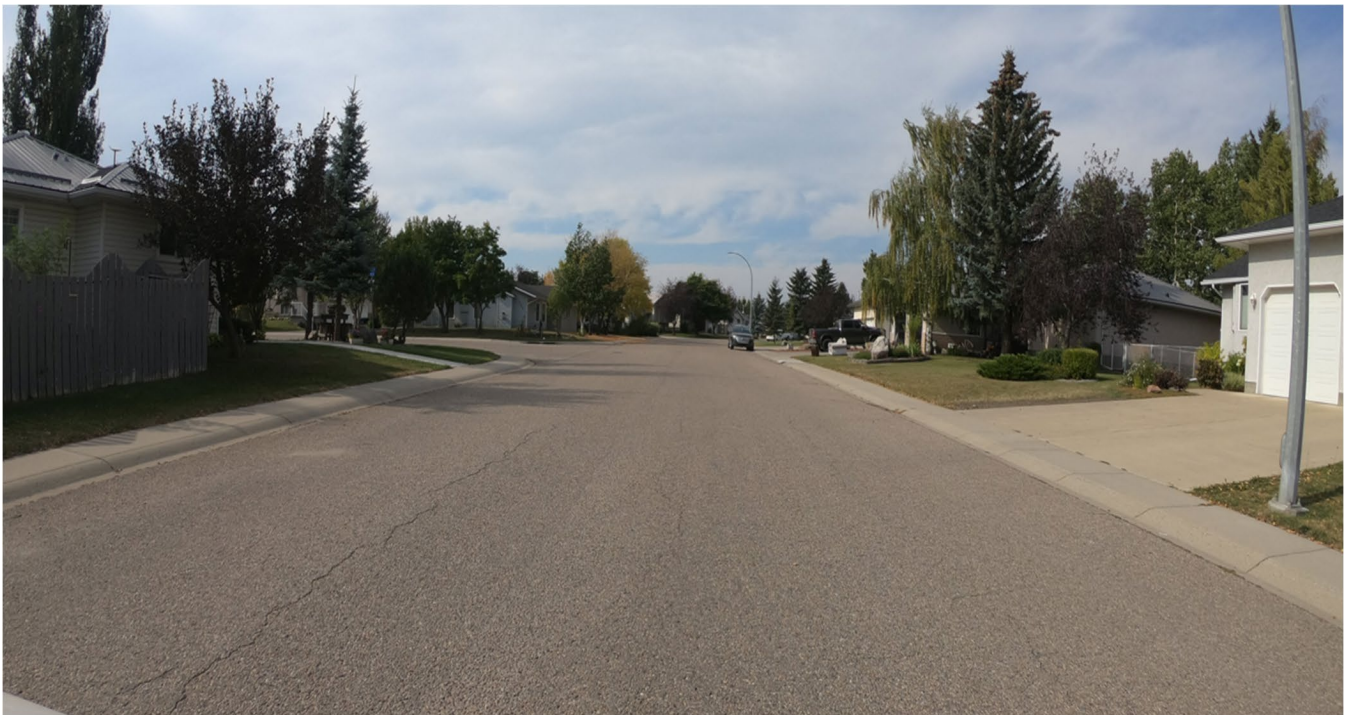
This section on 26th Street is moderately deteriorated, with minor longitudinal and transverse cracking, moderate surface raveling.

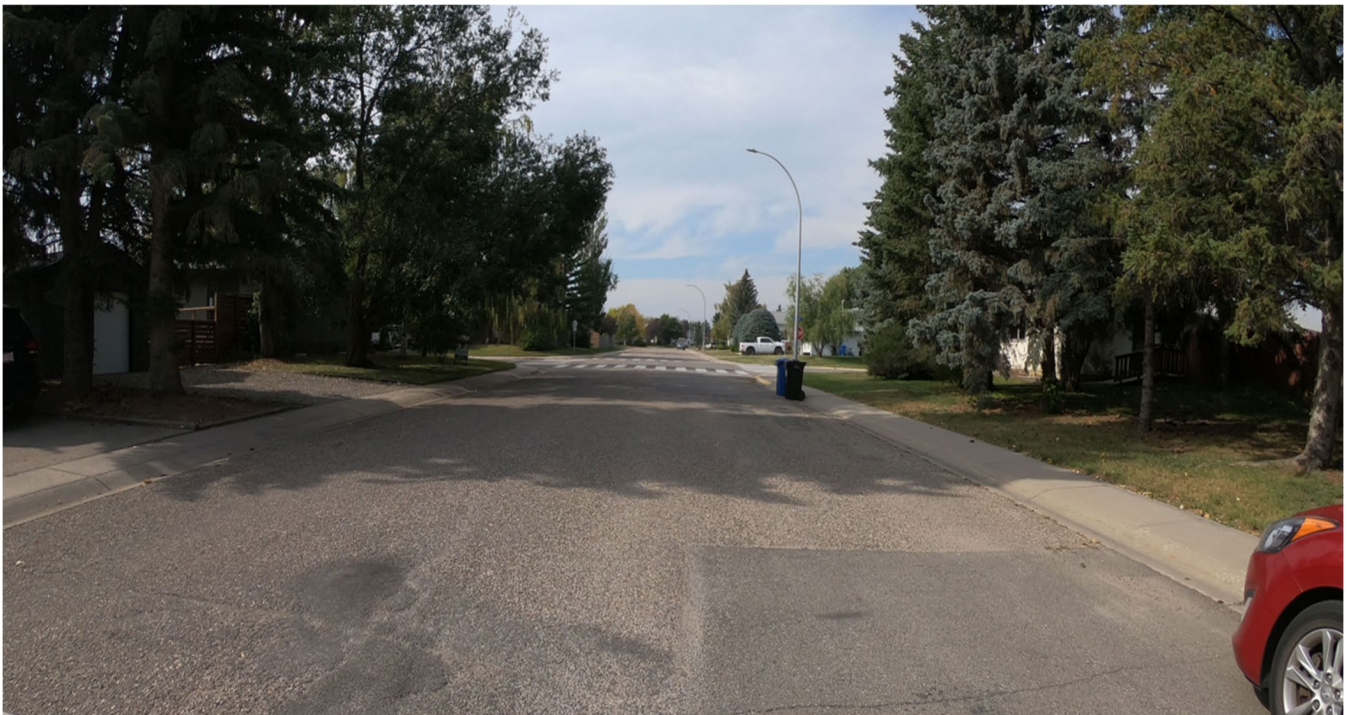
This section on 26th Street is moderately deteriorated, with minor longitudinal and transverse cracking, moderate age hardening and surface raveling.

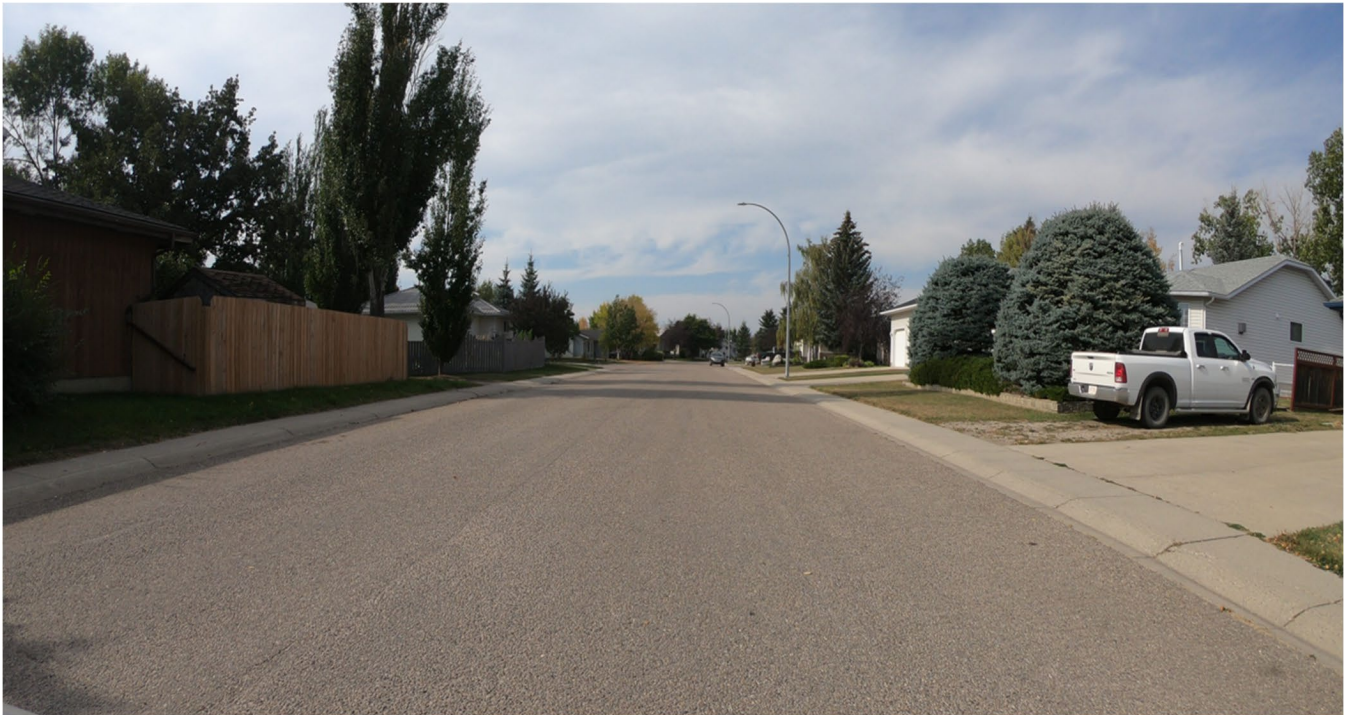
This section on 26th Street is moderately deteriorated, with minor longitudinal and transverse cracking, moderate age hardening and surface raveling.

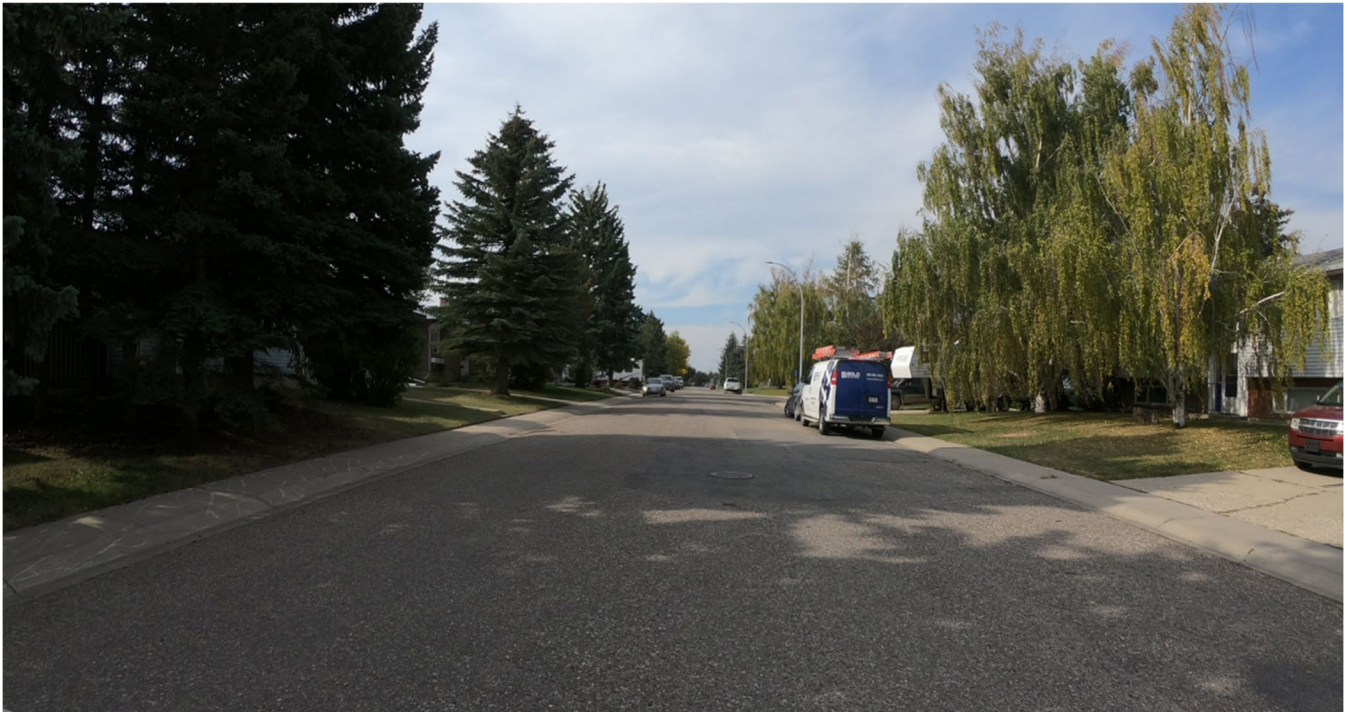
This section on 26th Street is moderately deteriorated, with minor longitudinal and transverse cracking, moderate age hardening and surface raveling.

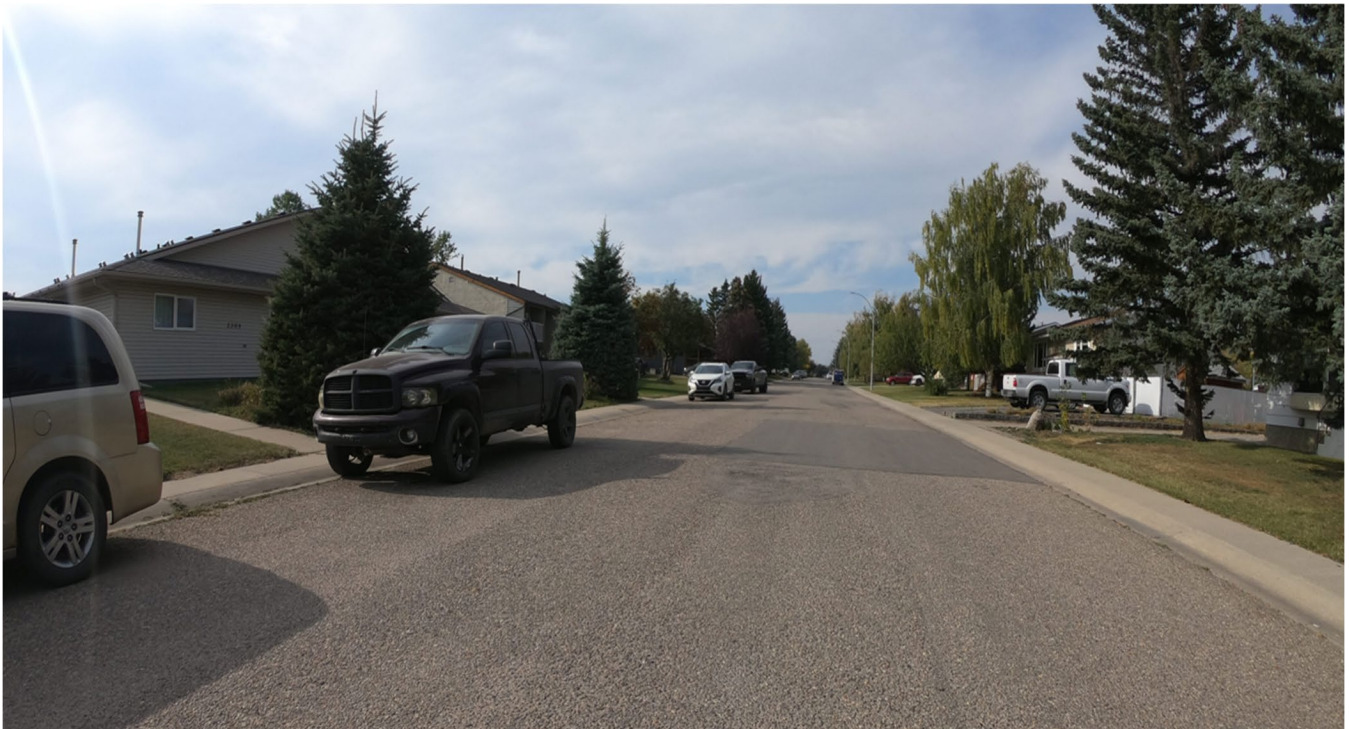
This section on 27th Street is moderately deteriorated, with minor longitudinal and transverse cracking, moderate surface raveling.

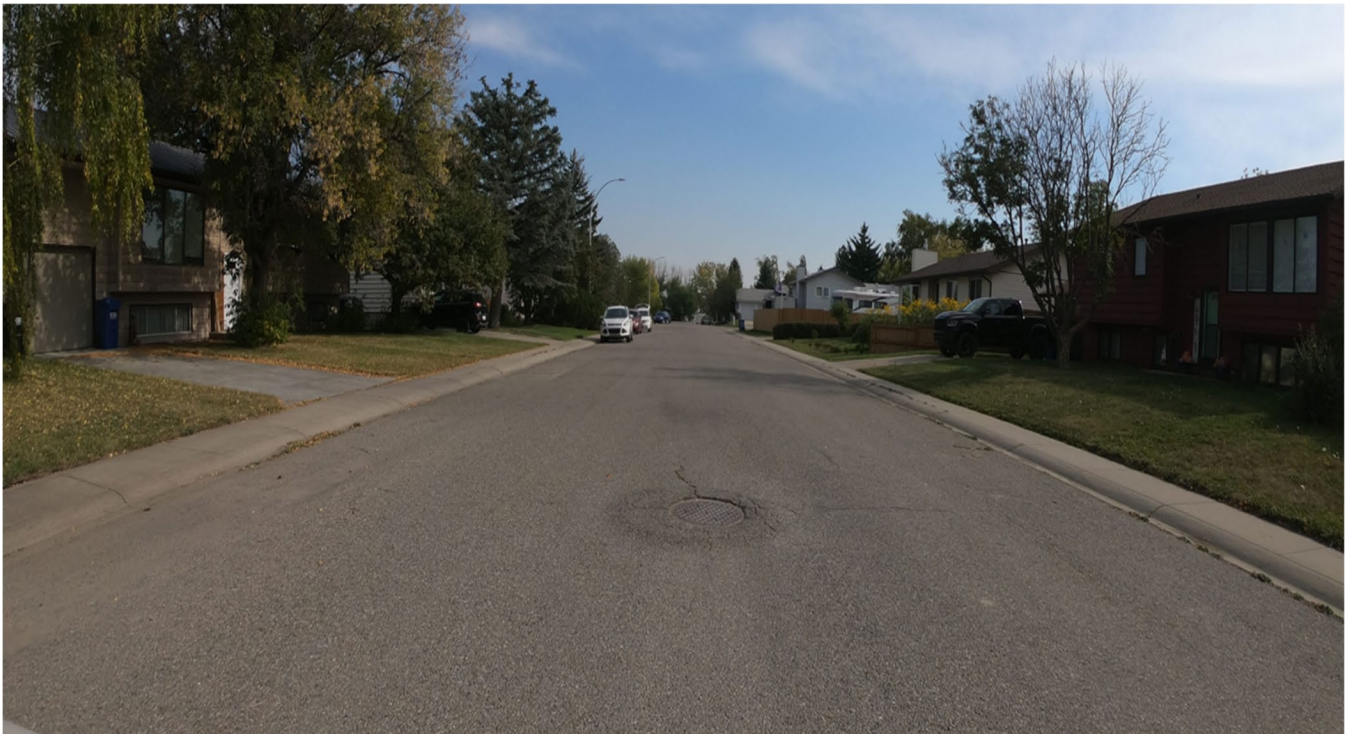
This section on 27th Street is moderately deteriorated, with minor longitudinal and transverse cracking, moderate age hardening and surface raveling.

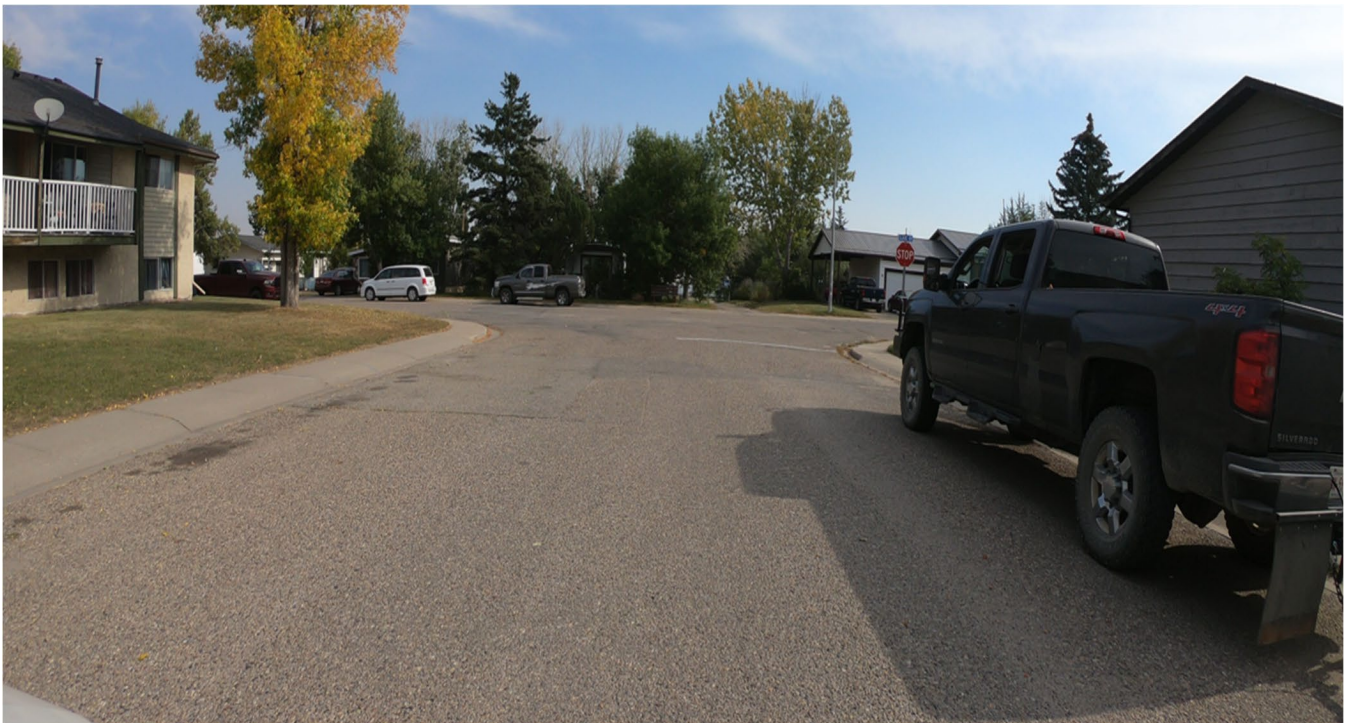
This section on 22A Avenue is moderately deteriorated, with minor longitudinal and transverse cracking, moderate age hardening and surface raveling.

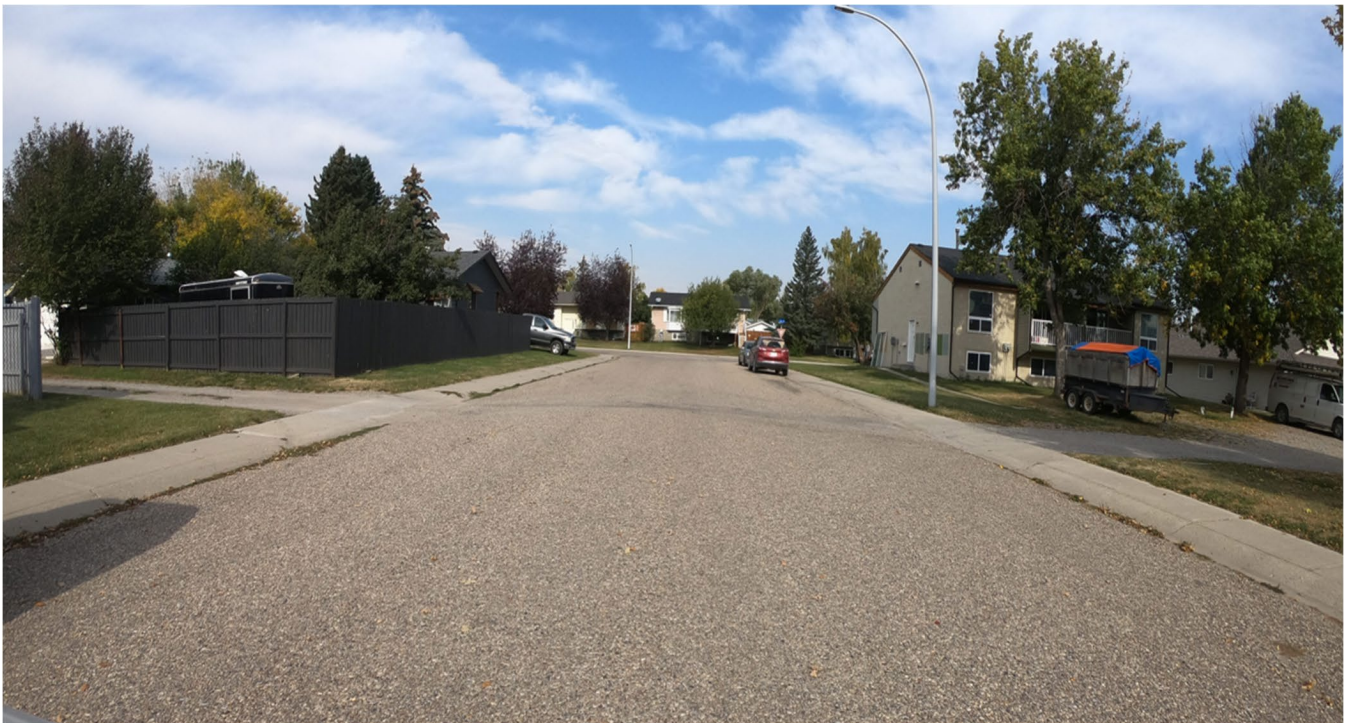
This section on 22A Avenue is moderately deteriorated, with minor longitudinal and transverse cracking, moderate age hardening and surface raveling.
