Town of Nanton

2025 Road Assessment

CIMA+ file number: Z0027712
September 2025

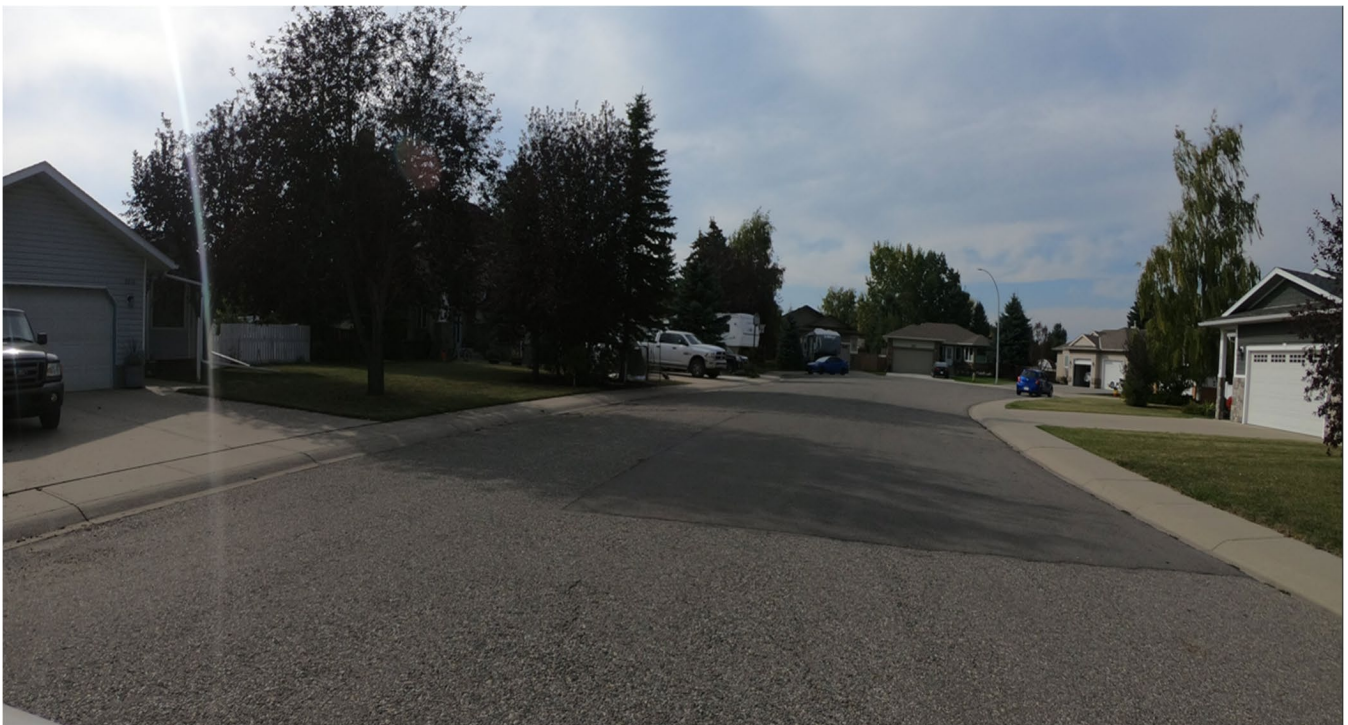
This section on 22nd Avenue is moderately deteriorated, with minor longitudinal and transverse cracking, moderate age hardening and surface raveling.

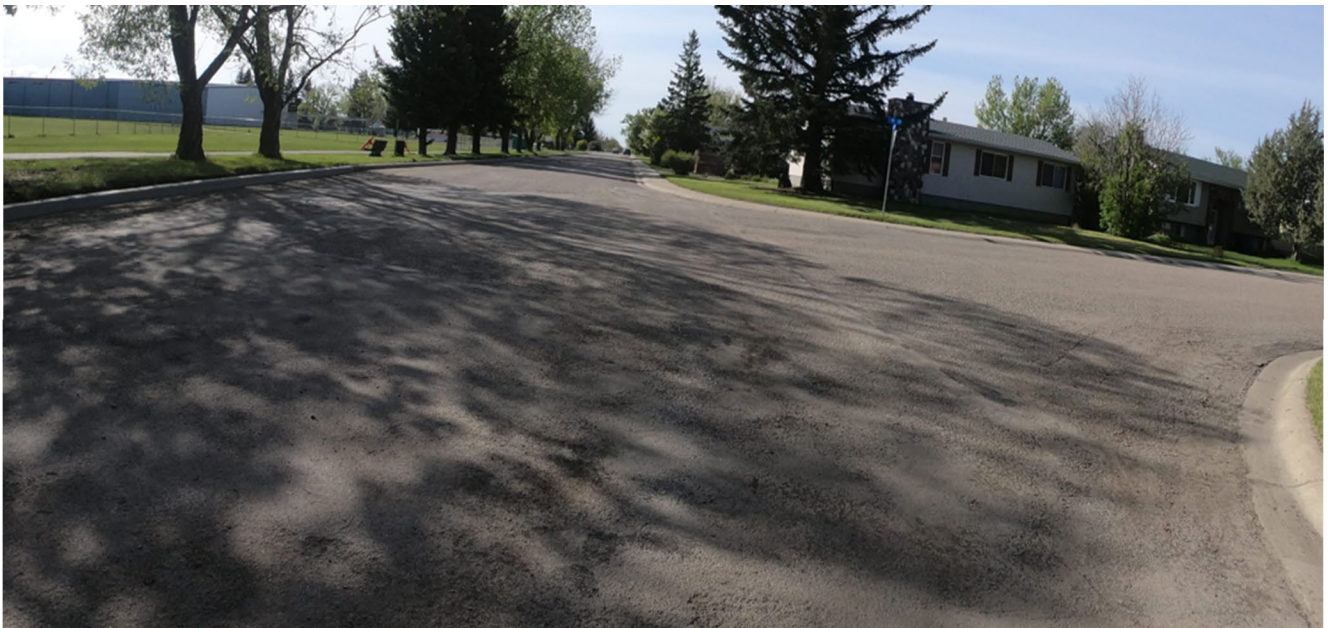
This section on 22nd Avenue is moderately deteriorated, with minor longitudinal and transverse cracking, moderate age hardening and surface raveling.

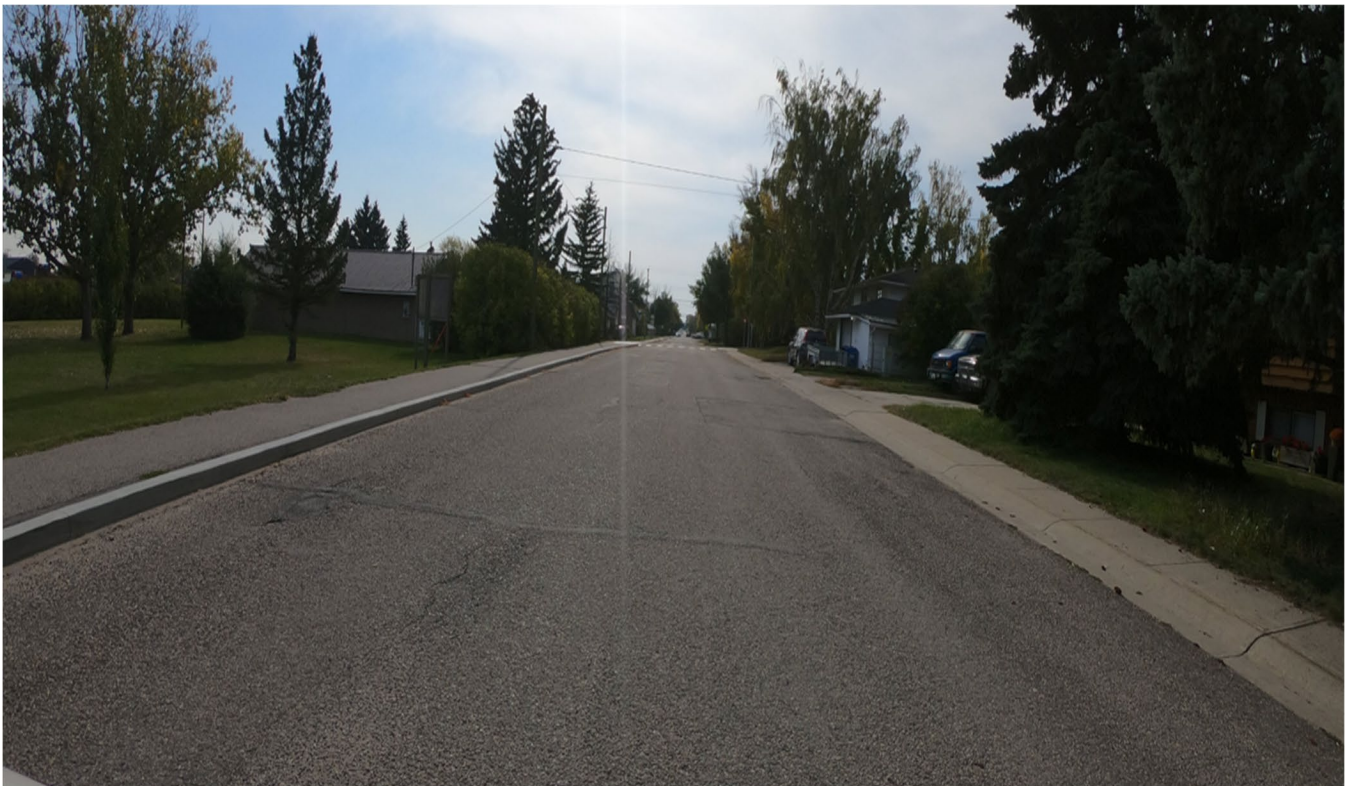
This section on 22nd Avenue is moderately deteriorated, with minor longitudinal and transverse cracking throughout. Sever age hardening and surface raveling.

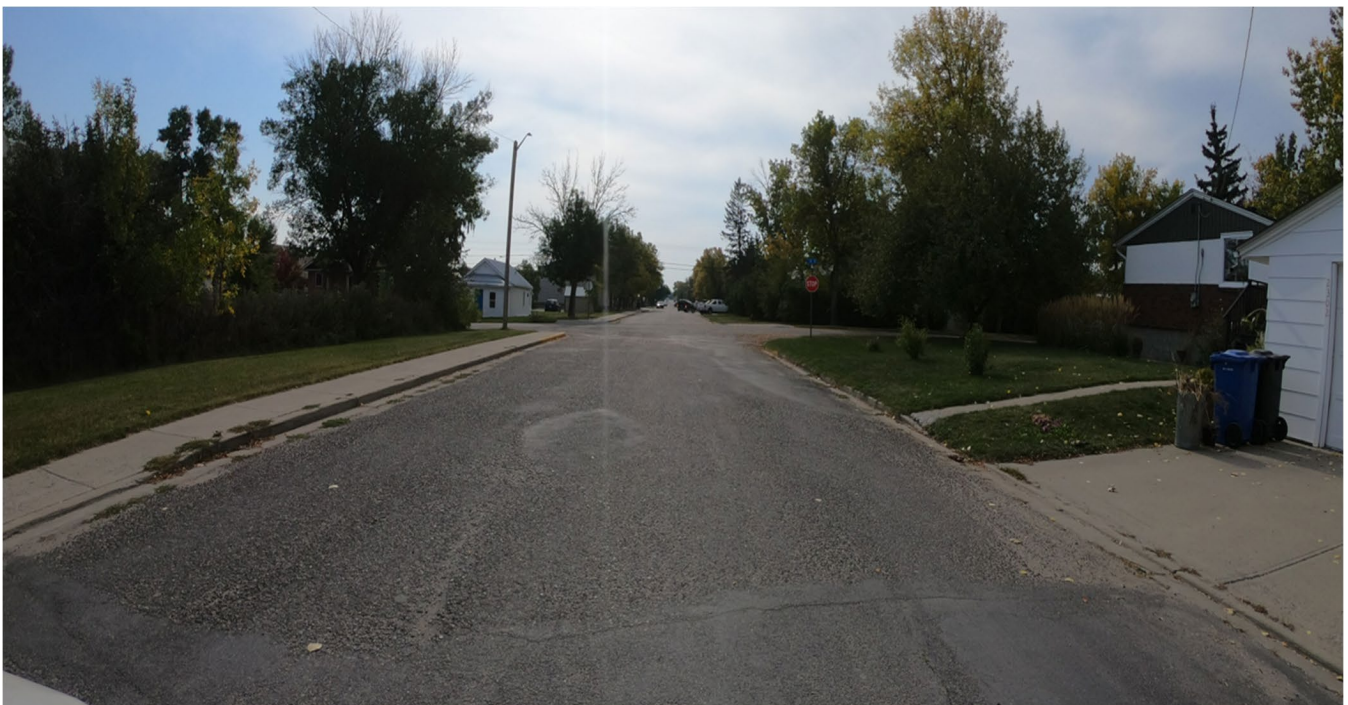
This section on 22nd Avenue is moderately deteriorated, with minor longitudinal and transverse cracking throughout. Sever age hardening and surface raveling.

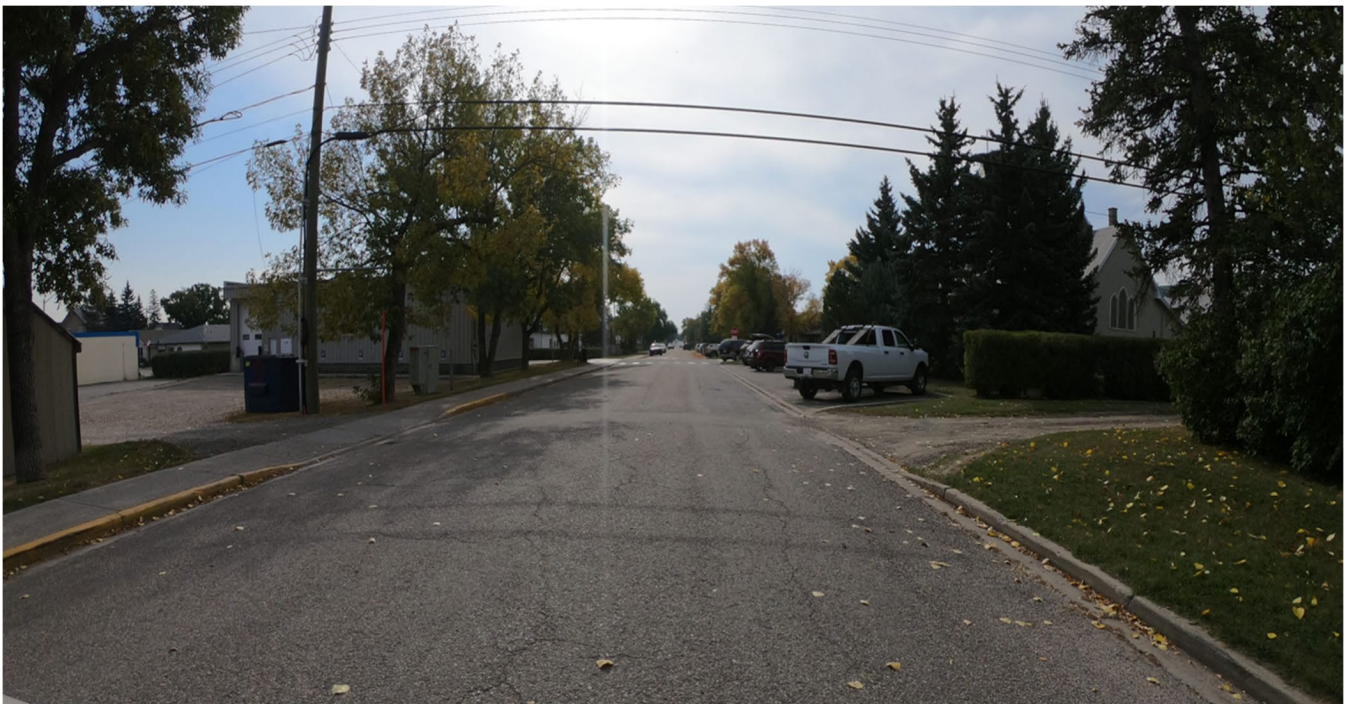
This section on 22nd Avenue is moderately deteriorated, with minor longitudinal and transverse cracking throughout. Sever age hardening and surface raveling.

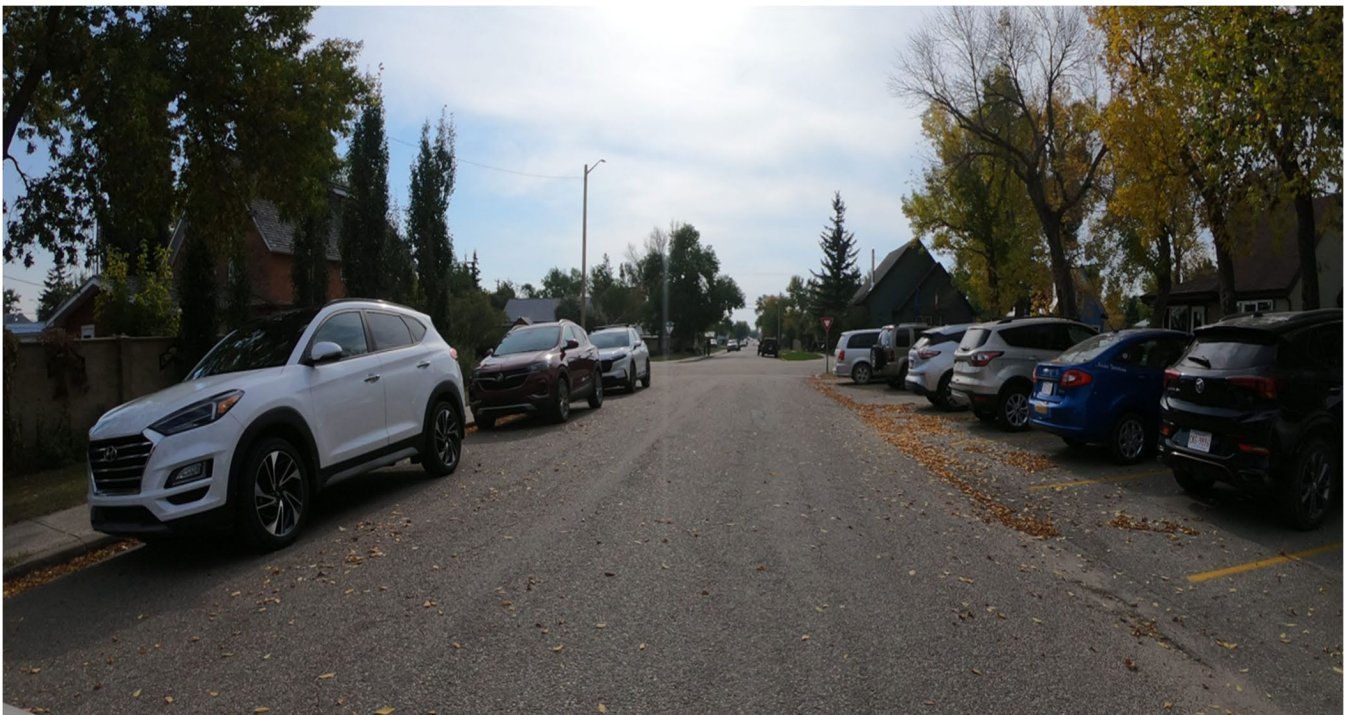
This section on 22nd Avenue is moderately deteriorated, with minor longitudinal and transverse cracking throughout. Sever age hardening and surface raveling.

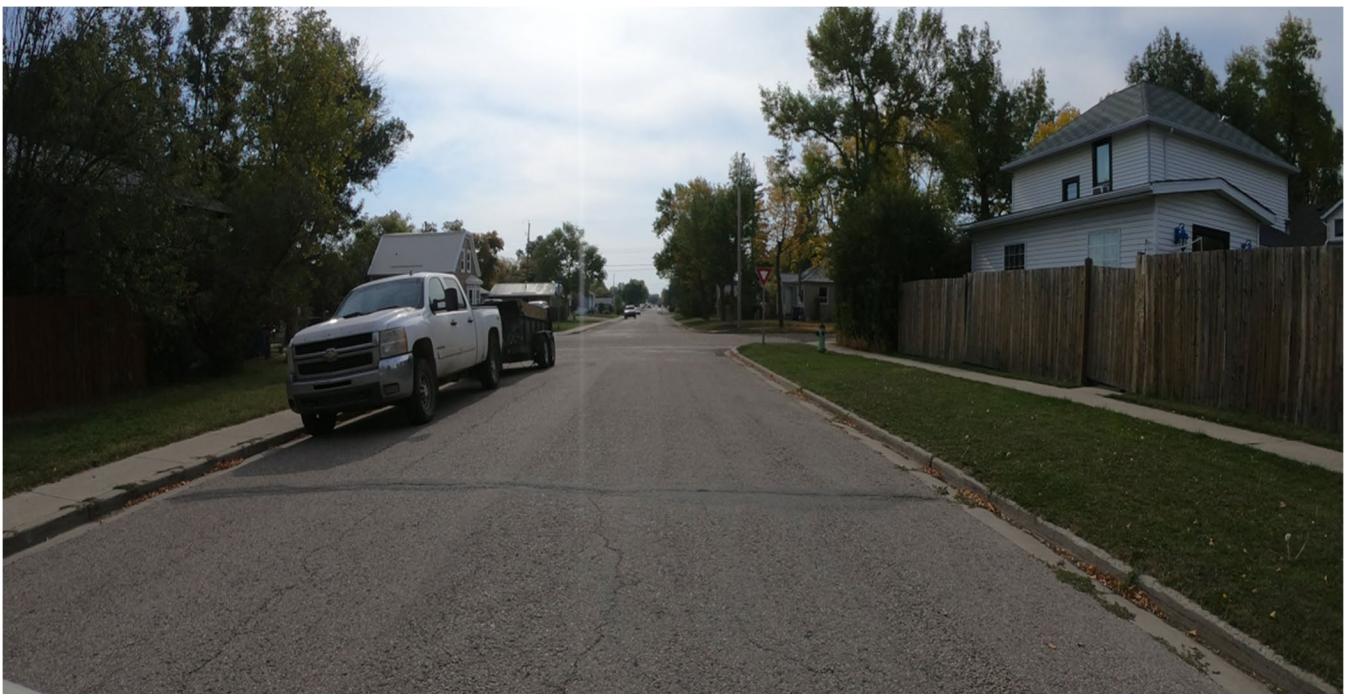
This section on 22nd Avenue is moderately deteriorated, with minor longitudinal and transverse cracking throughout. Sever age hardening and surface raveling.

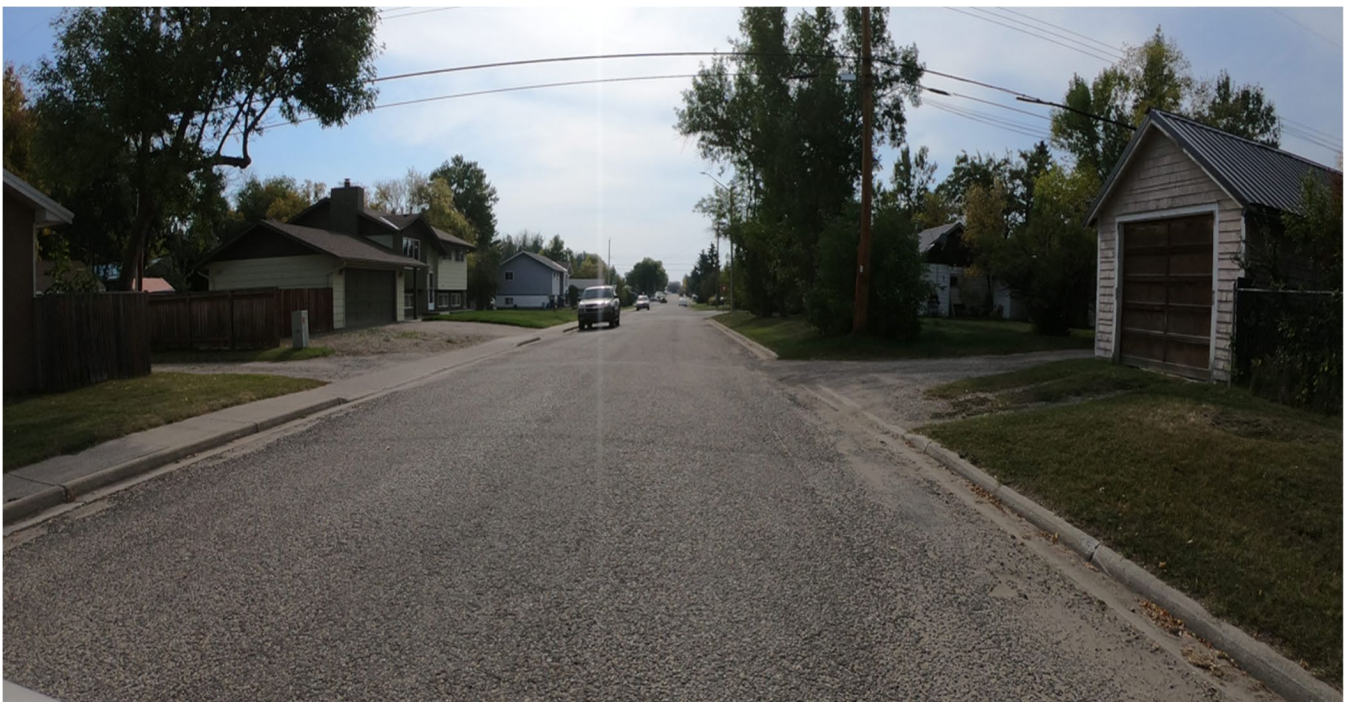
This section on 22nd Avenue is moderately deteriorated, with minor longitudinal and transverse cracking throughout. Sever age hardening and surface raveling.

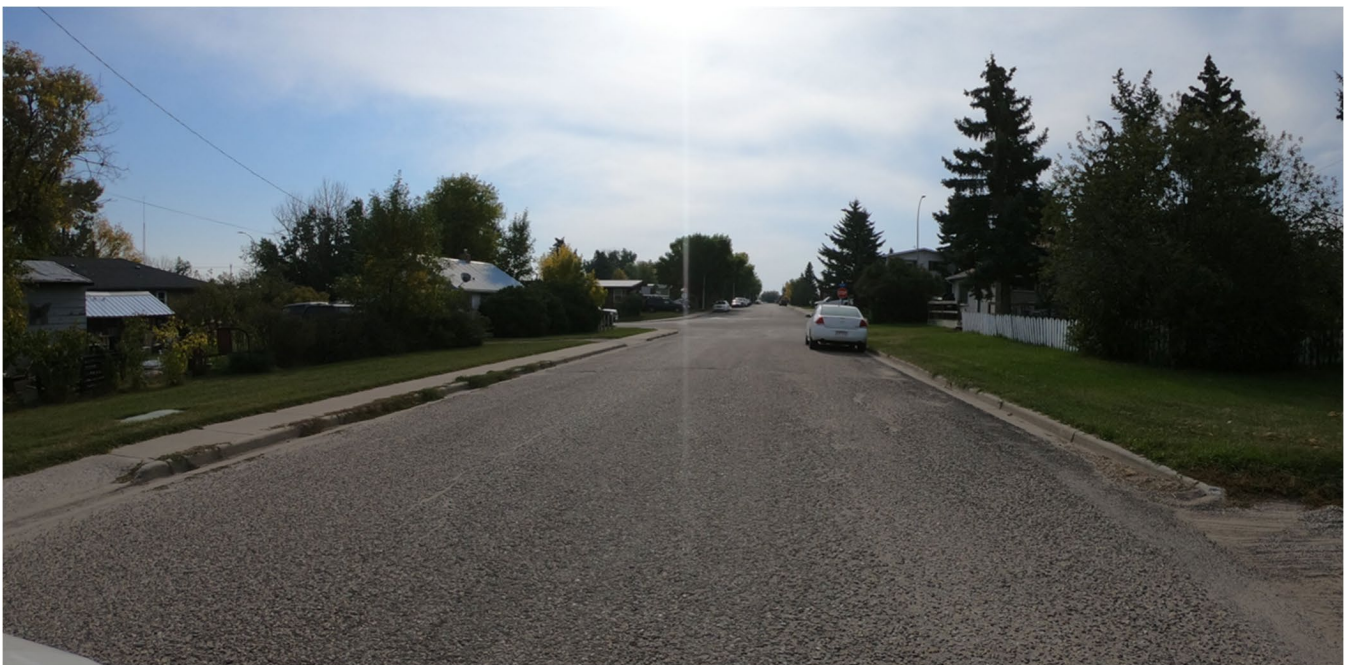
This section on 23rd Avenue is moderately deteriorated, with moderate longitudinal and transverse cracking throughout. Sever age hardening and surface raveling.
